TEST REPORT

No. : XMIN2006005124CM

Sample Name : SPC FLOOR
 Product Specification : SPC floor 5.5mm thickness (included EVA 1.5mm)
 Manufacturer : An Cuong High-tech Building Materials Joint Stock Company
 Material and Mark : PVC+Calcium carbonat + Additives

No.	Test Item	Test Method	Result
1	Determination of Impact Sound Insulation Class	ASTM E492-09(2016) ^{ε1} ASTM E989-18	IIC = 69

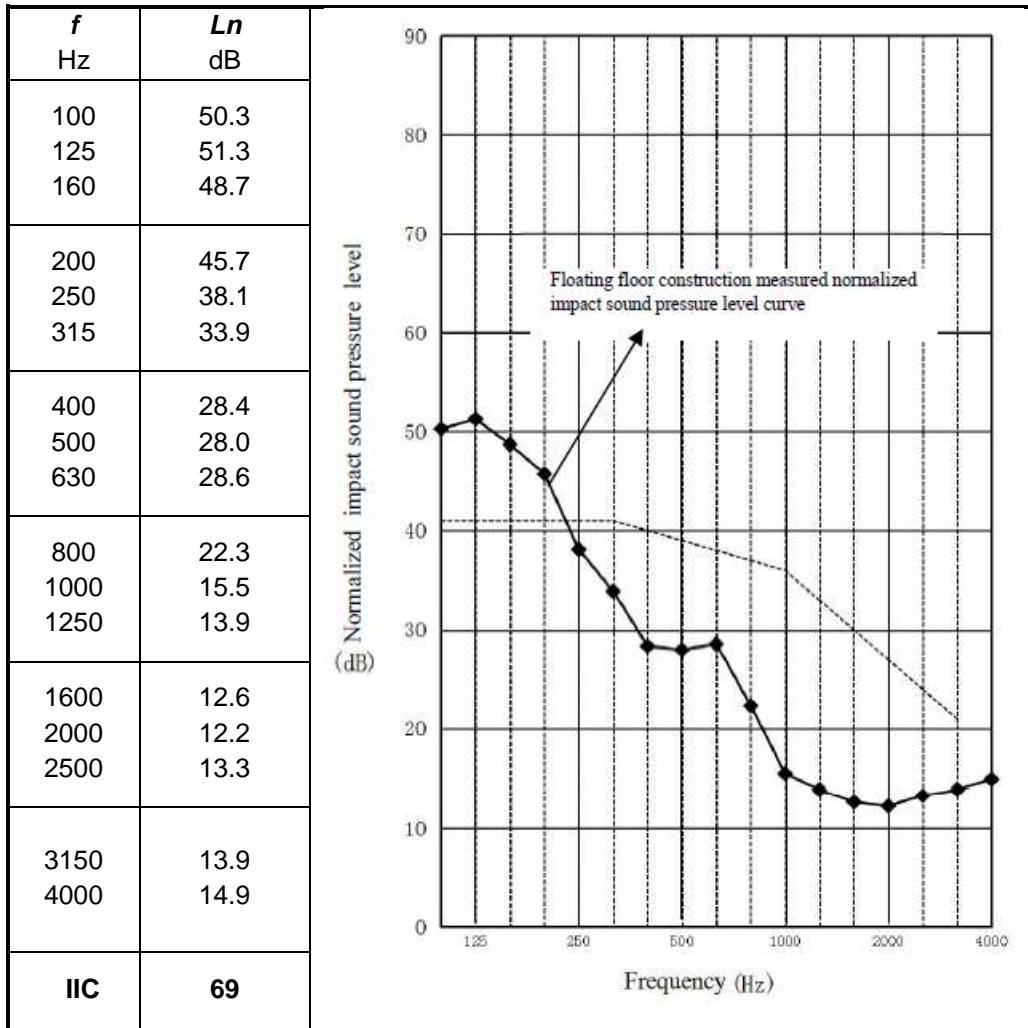
Frequency spectrum for IIC

Remark: L_n as the weighted normalized impact sound pressure level

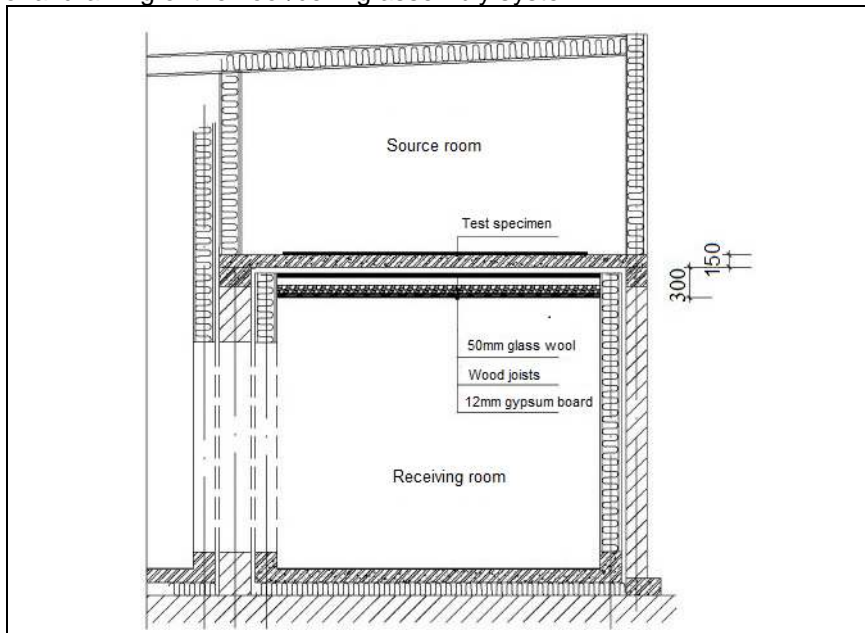
The constructional drawing of the floor/ceiling assembly system

- Sample Description : Flooring (see the photo)
Total Thickness: 5.5(4+1.5) mm, surface density: about 8.1kg/m², at the bottom of the sample with 1.5mm cushion pad.
- Test conducted : ASTM E492-09(2016)^{ε1}, ASTM E989-18
- Project description : No decoration of sample surface, sample installation was assembled directly.
The test specimen was covered on a 150mm concrete floor with a drop ceiling, testing area 11.3m², the drop ceiling construction showed in the following
Drop ceiling: 288mm cavity filled with 50mm glass wool, 12mm gypsum board.
- Test Equipment : RTA840 system
- Test Environment : Source room volume 125m³, receiving room volume 100m³, air temperature 22.2°C, air humidity 60.2%
