TEST REPORT

No. : XMIN2006005123CM

Sample Name : SPC FLOOR
Product Specification : SPC floor 5.5mm thickness (included EVA 1.5mm)
Manufacturer : An Cuong High-tech Building Materials Joint Stock Company
Material and Mark : PVC+Calcium carbonat + Additives

No.	Test Item	Test Method	Result
1	Airborne sound transmission loss test and class	ASTM E90-09(2016) ASTM E413-16	STC = 68

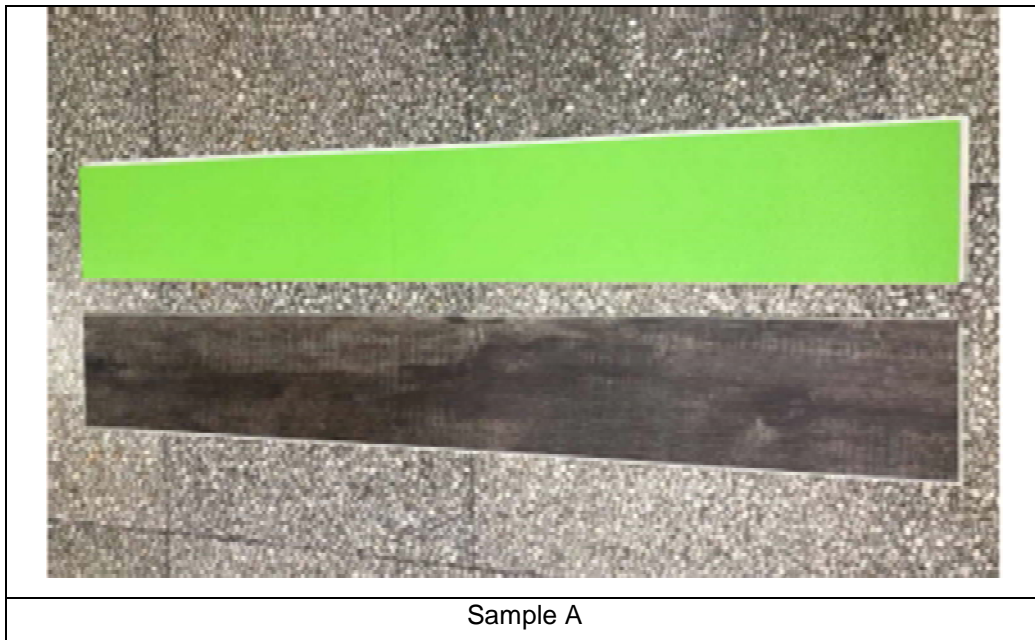
Original Sample Photo:

- Sample Description : Flooring (see the photo)
Total Thickness: 5.5(4+1.5) mm, surface density: about 8.1kg/m², at the bottom of the sample with 1.5mm cushion pad.
- Test conducted : ASTM E90-09(2016), ASTM E413-16
- Project description : No decoration of sample surface, sample installation was assembled directly.
The test specimen was covered on a 150mm concrete floor with a drop ceiling, testing area 11.3m², the drop ceiling construction showed in the following
Drop ceiling: 288mm cavity filled with 50mm glass wool, 12mm gypsum board.
- Test Equipment : RTA840 system
- Test Environment : Source room volume 125m³, receiving room volume 100m³, air temperature 22.2°C, air humidity 60.2%

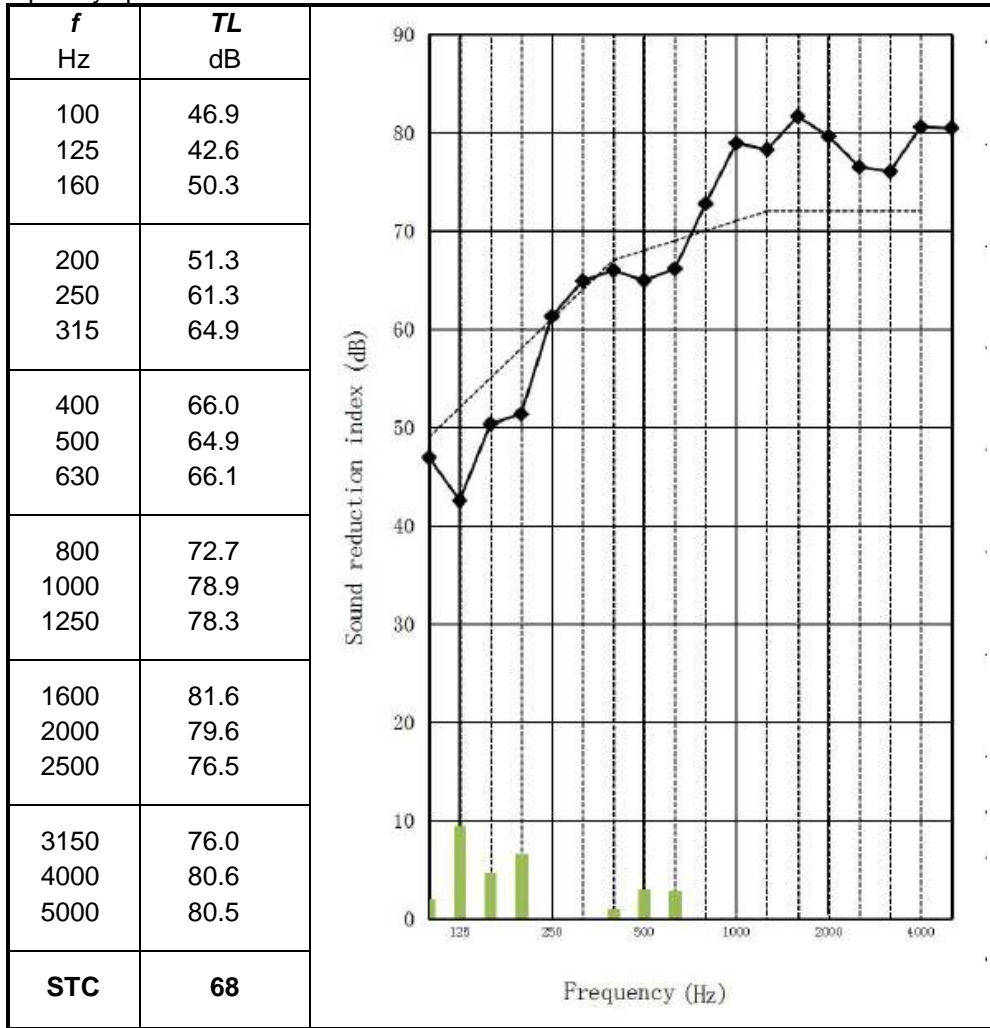
Frequency spectrum for STC

Remark: 1. TL is the transmission loss.
