TEST REPORT

No. : XMIN2006005120CM

Sample Name : SPC FLOOR
Product Specification : SPC floor 5mm thickness (included IXPE 1.5mm)
Manufacturer : An Cuong High-tech Building Materials Joint Stock Company
Material and Mark : PVC+Calcium carbonat + Additives

No.	Test Item	Test Method	Result
1	Airborne sound transmission loss test and class	ASTM E90-09(2016) ASTM E413-16	STC = 68

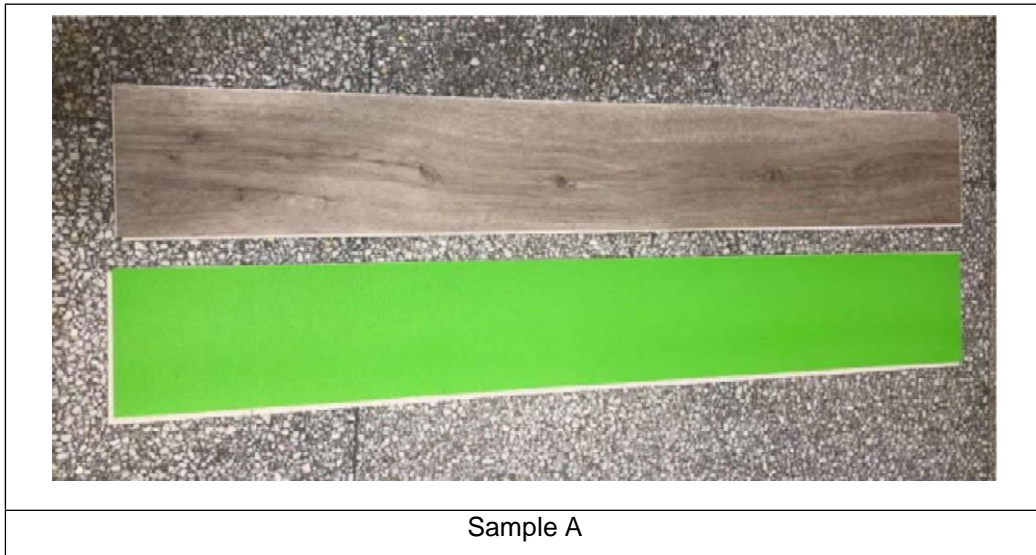
Original Sample Photo:

- Sample Description : Flooring (see the photo)
Total Thickness: 5 (4+1.0) mm, surface density: about 8.1kg/m², at the bottom of the sample with 1.0mm cushion pad.
- Test conducted : ASTM E90-09(2016), ASTM E413-16
- Project description : No decoration of sample surface, sample installation was assembled directly.
The test specimen was covered on a 150mm concrete floor with a drop ceiling, testing area 11.3m², the drop ceiling construction showed in the following
Drop ceiling: 288mm cavity filled with 50mm glass wool, 12mm gypsum board.
- Test Equipment : RTA840 system
- Test Environment : Source room volume 125m³, receiving room volume 100m³, air temperature 22.2°C, air humidity 60.2%

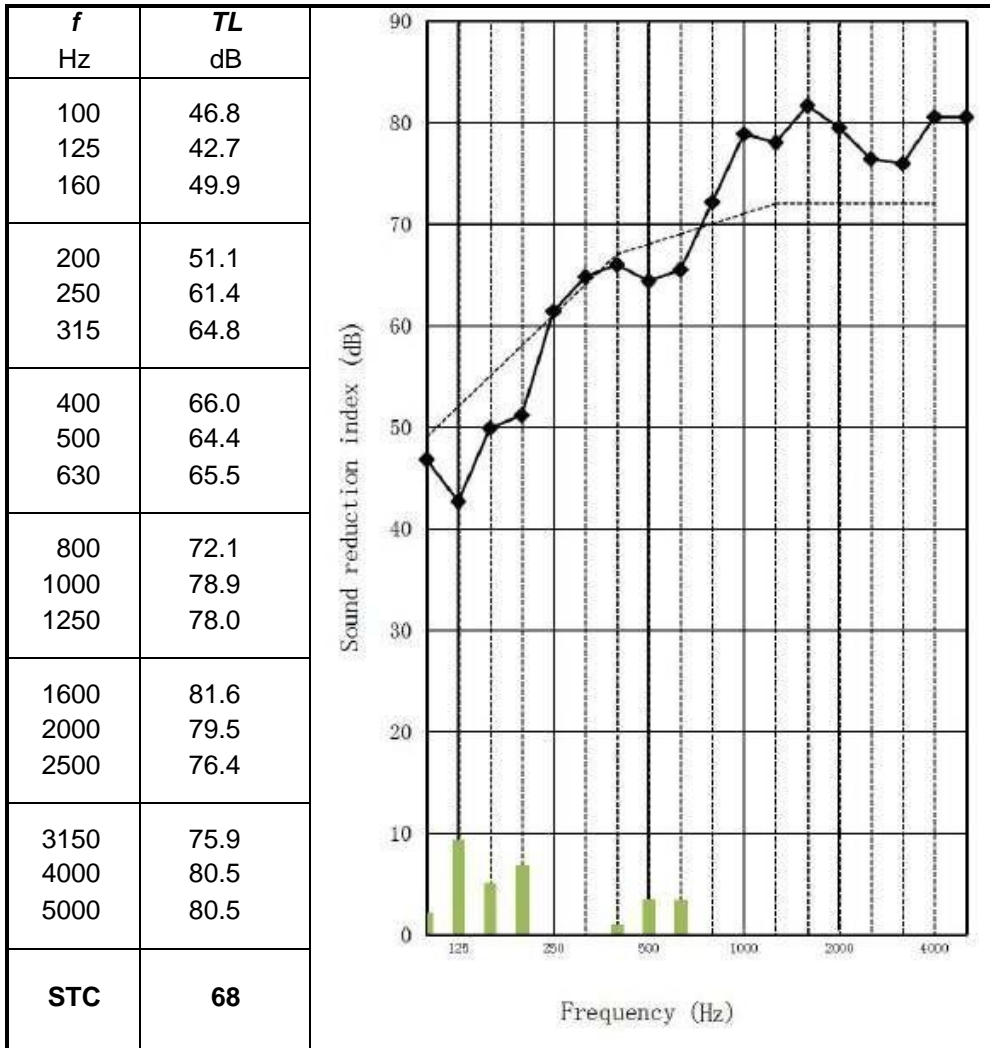
Frequency spectrum for STC

Remark: 1. *TL* is the transmission loss.
