## TEST REPORT

No. : XMIN2006005122CM

Sample Name : SPC FLOOR

Product Specification : SPC floor 5 mm thickness (included IXPE 1mm)

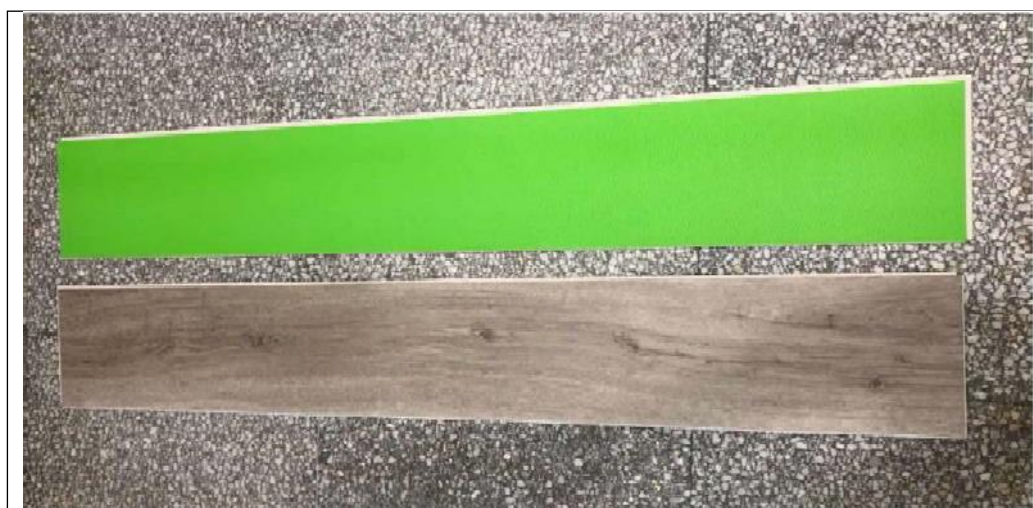
Sample A

## Original Sample Photo:

Sample Description : Flooring (see the photo)  
Total Thickness: 5 (4+1) mm, surface density: about 8.2kg/m<sup>2</sup>, at the bottom of the sample with 1.0mm cushion pad.

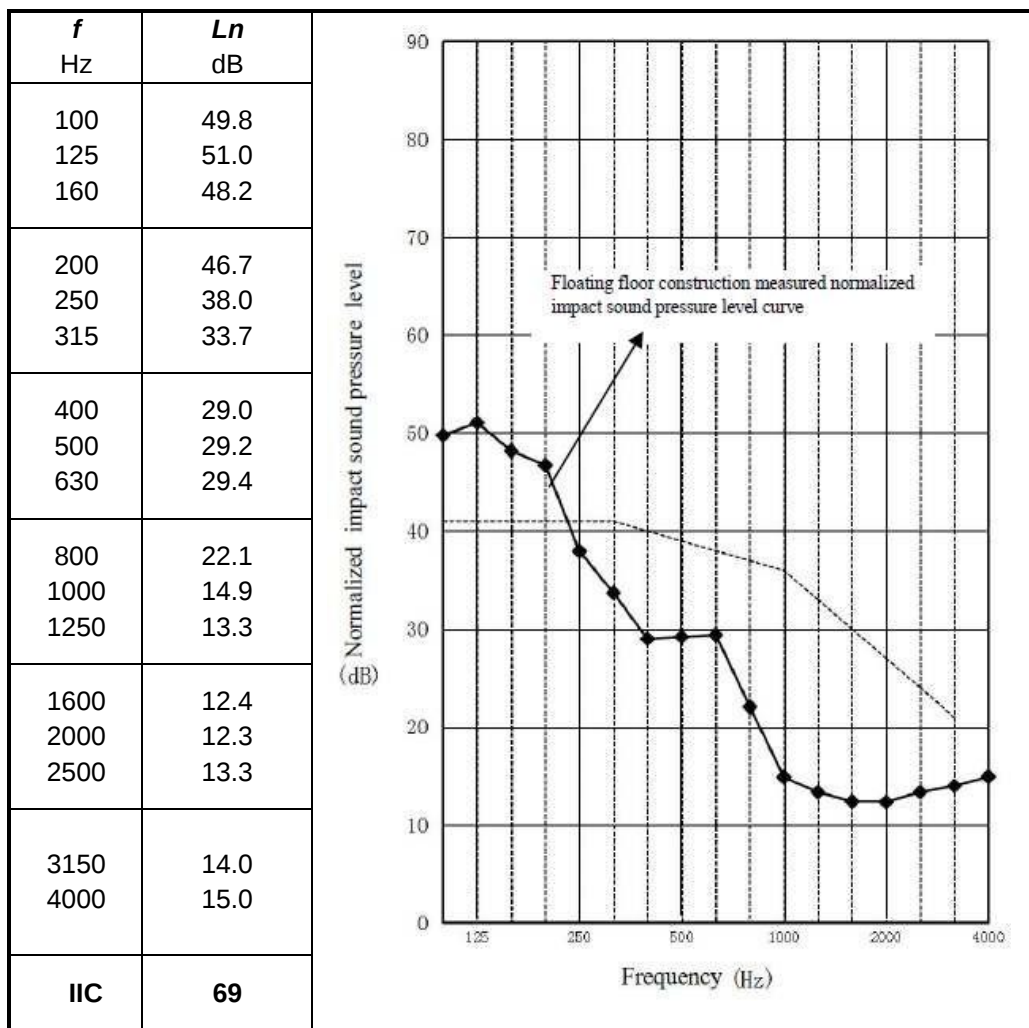
Frequency spectrum for IIC

Remark:  $L_n$  as the weighted normalized impact sound pressure level

| No. | Test Item | Test Method | Result |
|---|---|---|---|
| 1 | Determination of Impact<br>Sound Insulation Class | ASTM E492-09(2016) <sup>e1</sup><br>ASTM E989-18 | IIC = 69 |
