## TEST REPORT

No. : XMIN2006005123CM

Sample Name : SPC FLOOR

Product Specification : SPC floor 5.5mm thickness (included EVA 1.5mm)

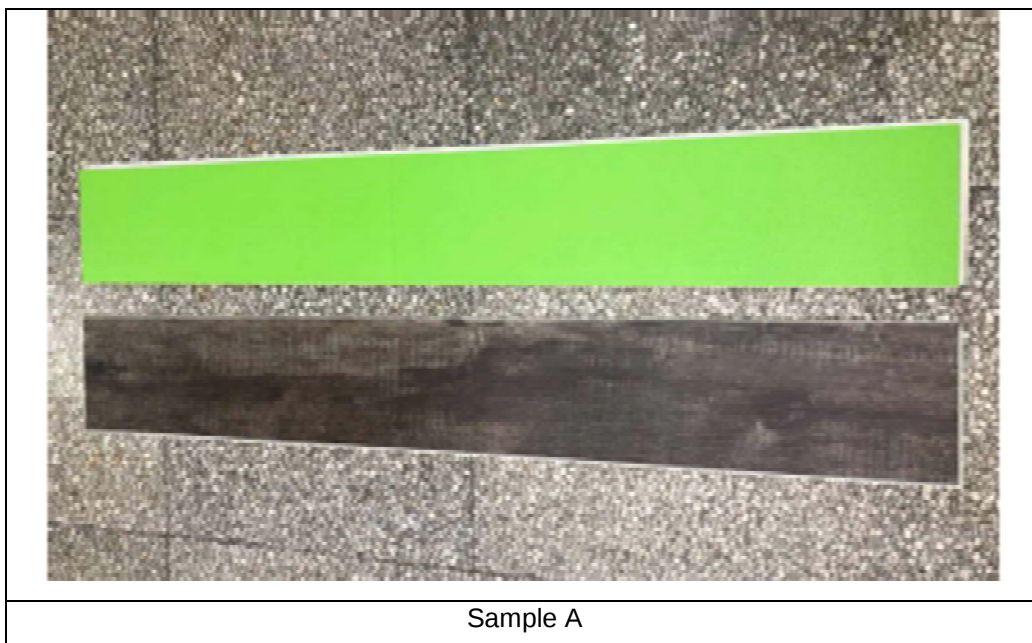
Sample A

### Original Sample Photo:

Sample Description : Flooring (see the photo)  
Total Thickness: 5.5(4+1.5) mm, surface density: about 8.1kg/m<sup>2</sup>, at the bottom of the sample with 1.5mm cushion pad.

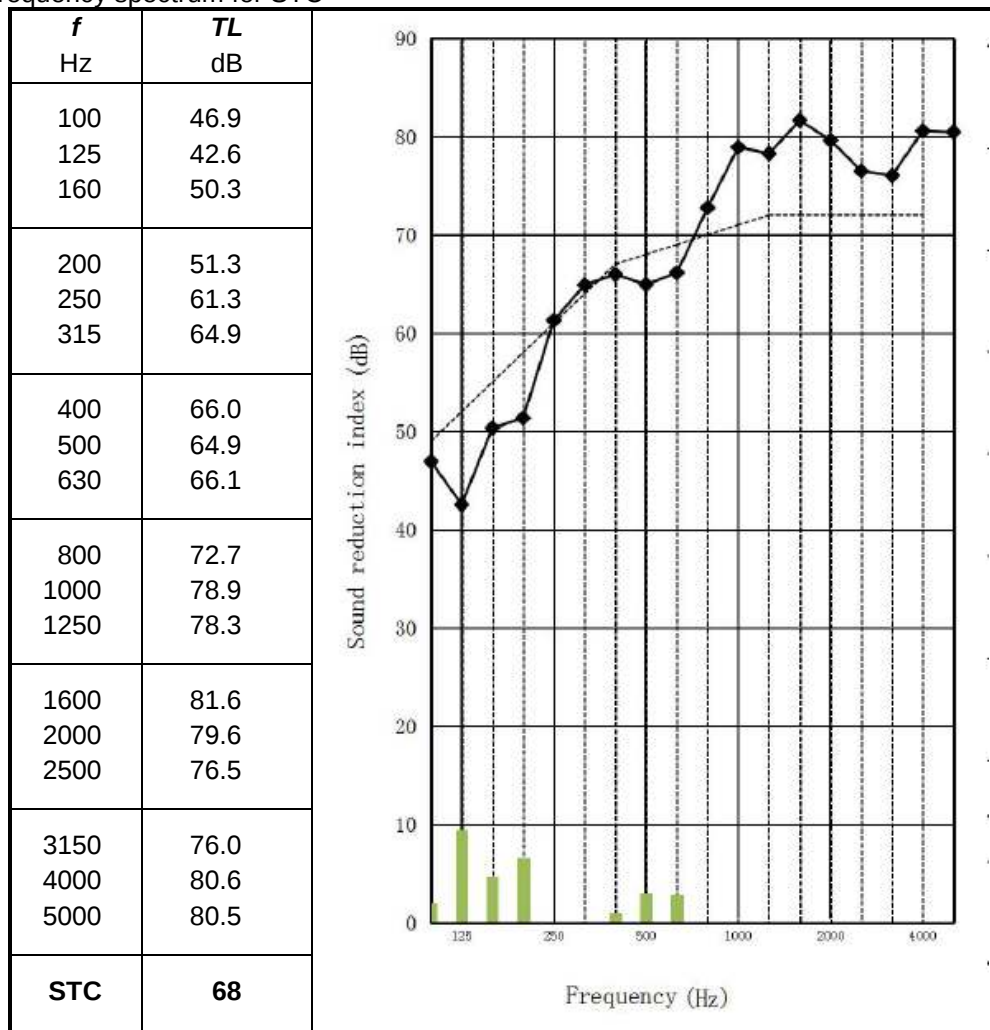
Frequency spectrum for STC

Remark: 1. TL is the transmission loss.

| No. | Test Item | Test Method | Result |
|---|---|---|---|
| 1 | Airborne sound transmission loss test and class | ASTM E90-09(2016)<br>ASTM E413-16 | STC = 68 |

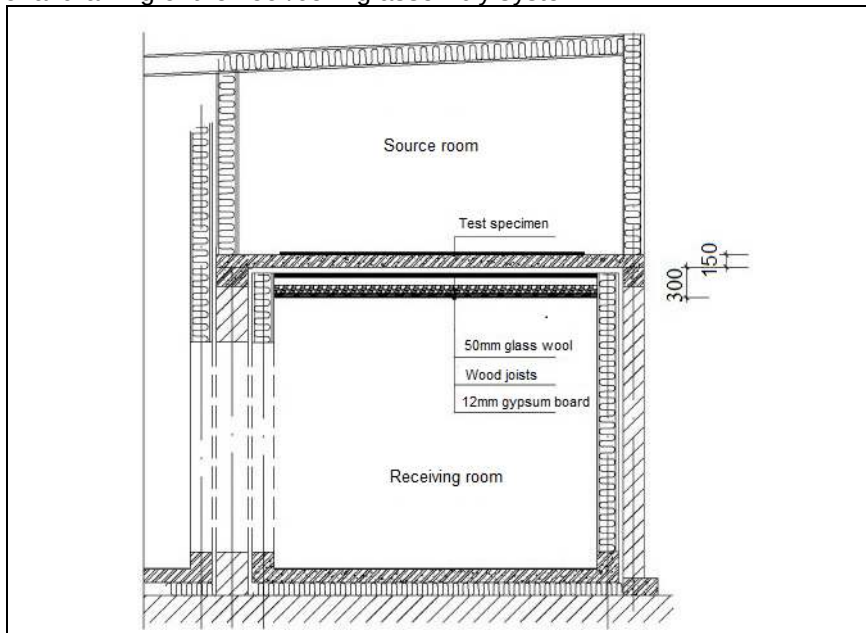
The constructional drawing of the floor/ceiling assembly system

Project description : No decoration of sample surface, sample installation was assembled directly.  
The test specimen was covered on a 150mm concrete floor with a drop ceiling, testing area 11.3m<sup>2</sup>, the drop ceiling construction showed in the following  
Drop ceiling: 288mm cavity filled with 50mm glass wool, 12mm gypsum board.

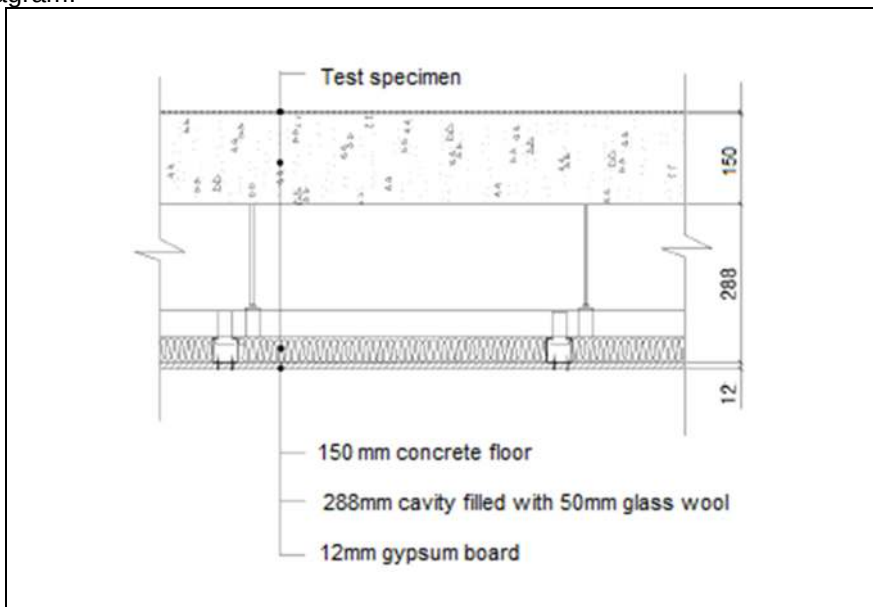
Schematic diagram:
