## TEST REPORT

No. : XMIN2006005120CM

Sample Name : SPC FLOOR

Product Specification : SPC floor 5mm thickness (included IXPE 1.0mm)

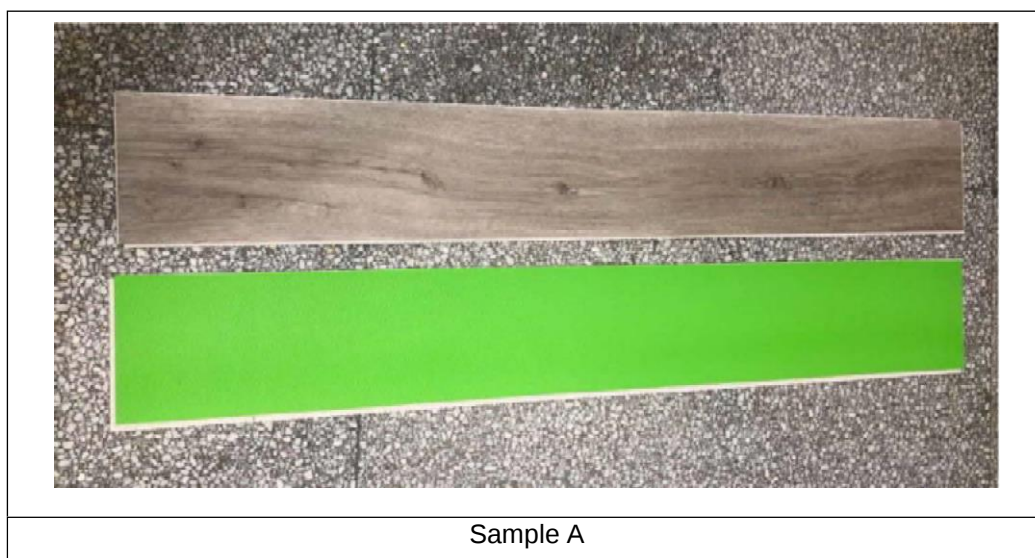
Sample A

### Original Sample Photo:

Sample Description : Flooring (see the photo)  
Total Thickness: 5 (4+1.0) mm, surface density: about 8.1kg/m<sup>2</sup>, at the bottom of the sample with 1.0mm cushion pad.

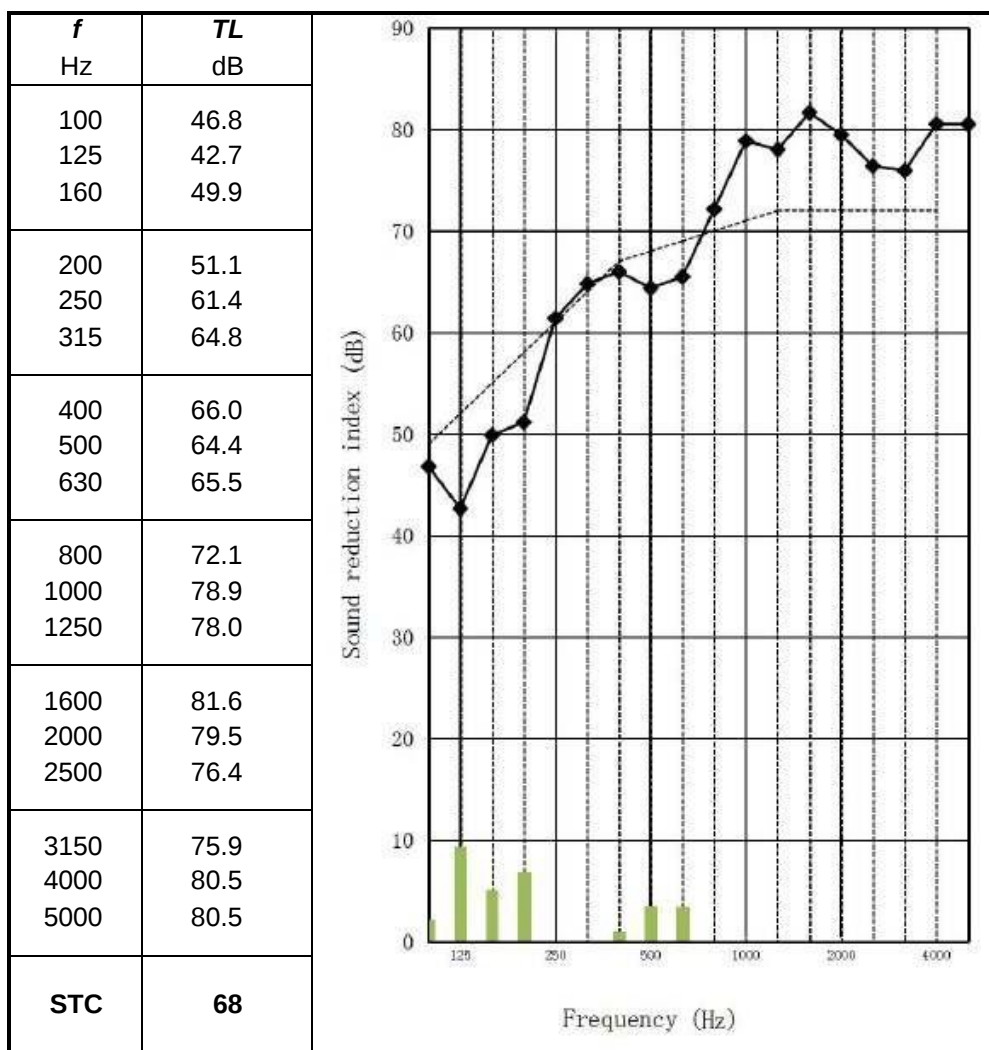
Frequency spectrum for STC

Remark: 1.  $TL$  is the transmission loss.

| No. | Test Item | Test Method | Result |
|---|---|---|---|
| 1 | Airborne sound transmission loss test and class | ASTM E90-09(2016)<br>ASTM E413-16 | STC = 68 |

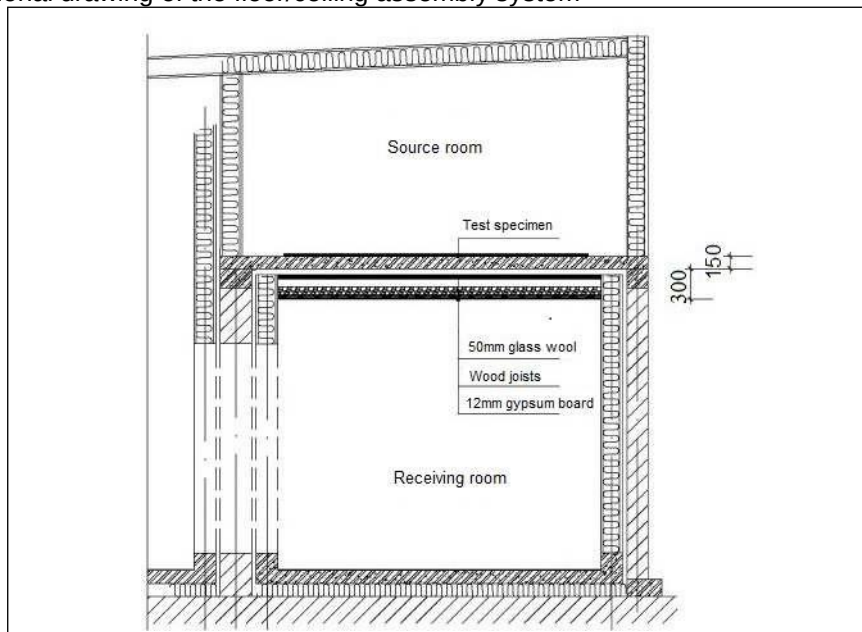
The constructional drawing of the floor/ceiling assembly system

Project description : No decoration of sample surface, sample installation was assembled directly.  
The test specimen was covered on a 150mm concrete floor with a drop ceiling, testing area 11.3m<sup>2</sup>, the drop ceiling construction showed in the following  
Drop ceiling: 288mm cavity filled with 50mm glass wool, 12mm gypsum board.
